SUBJECT: Ezere Airfield

Attachment: sketch of Ezere airfield.

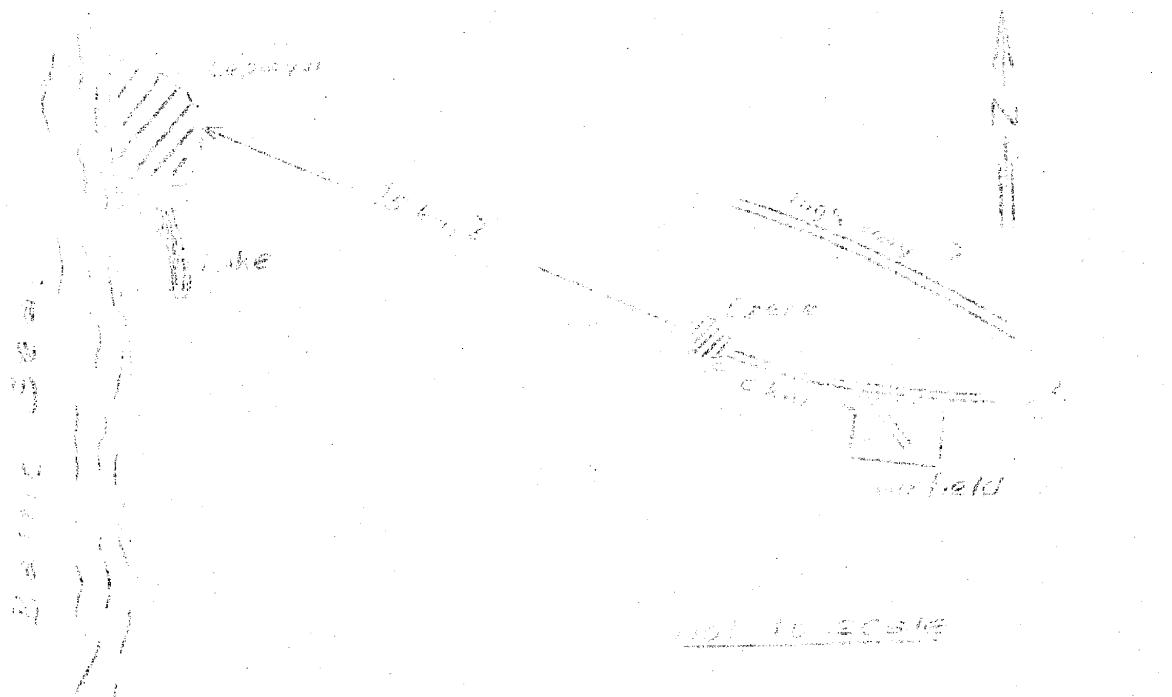
Top Sketch of B290 Aerials

1. Ezere airfield was a former German airfield, about  $1\frac{1}{2}$  km square, and was located about 2 km east of Ezere ( $56^{\circ}24'N/22^{\circ}22'E$ ), Lithuanian S.S.R., and about  $1\frac{1}{2}$  km south of a road leading from Ezere toward the east. The southwestern corner of the field bordered a wooded area. The runway, which extended from N to S, was about  $50 \times 1,500$  meters. It consisted of a subgrade 10 to 15 cm deep, filled with gravel, a layer of clay, and a concrete cover about 5 cm deep. The remaining field area had a grass cover. There was no drainage system.

2. Three hangars were under construction. One hangar, about  $10 \times 120$  meters, was located in the southwestern corner of the field. It was a steel and concrete structure with a concrete foundation, concrete floors, and a steel roof sloping to the rear which was covered with concrete slabs. Another hangar,  $25 \times 30$  meters, located on the southern edge and almost in the southeastern corner of the field, was constructed the same way. The third hangar, about  $25 \times 60$  meters, was located in the eastern section of the field, almost in the center. It was also a concrete structure. Steel rails for a traveling crane were being laid. Two concrete N-S ditches, each  $5 \times 12$  meters, probably for the establishment of an underground fuel dump, were in the southeastern corner of the field.
